**SITE INSPECTION REPORT
MARCH POINT LANDFILL
ANACORTES, WASHINGTON**

MARCH, 1986

SKAGIT COUNTY - MARCH POINT LANDFILL
ANACORTES, WASHINGTON

WAD980638944

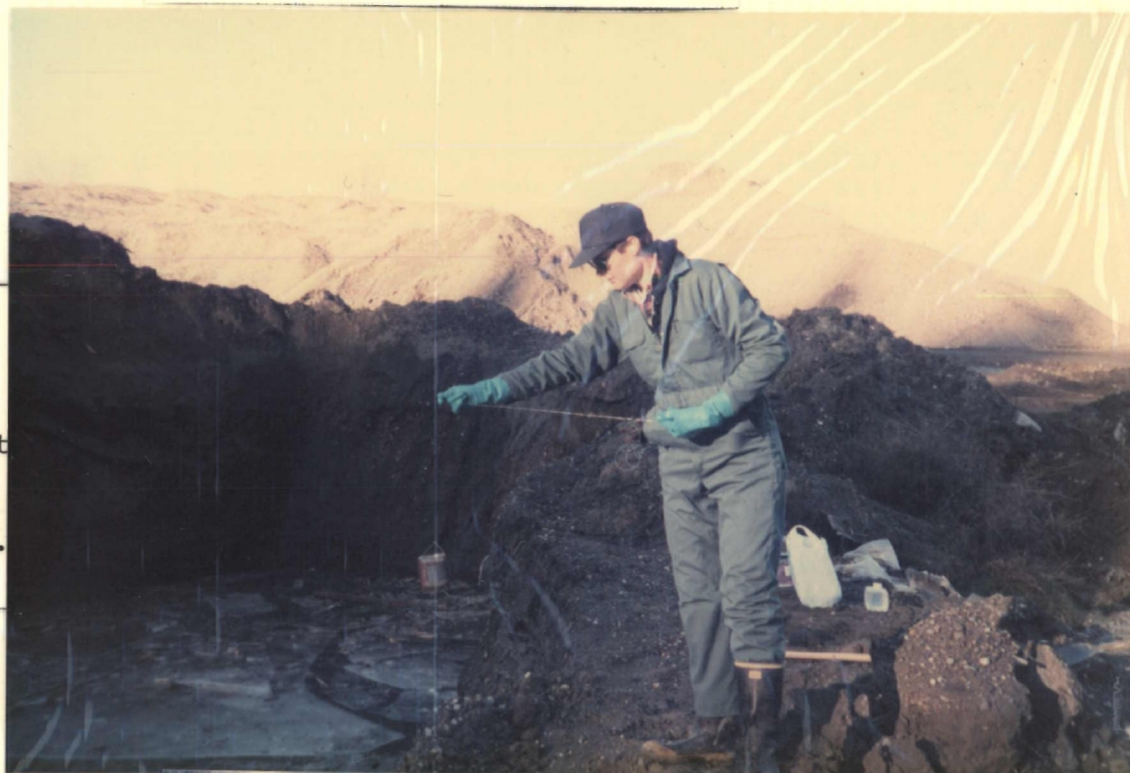
Ned Therien is shown here with the bailer used to collect sample NCT091. The surroundings of NW Concrete Company's barrow pit can be seen in the background. The gravel and sand soils can also be seen in this photograph.

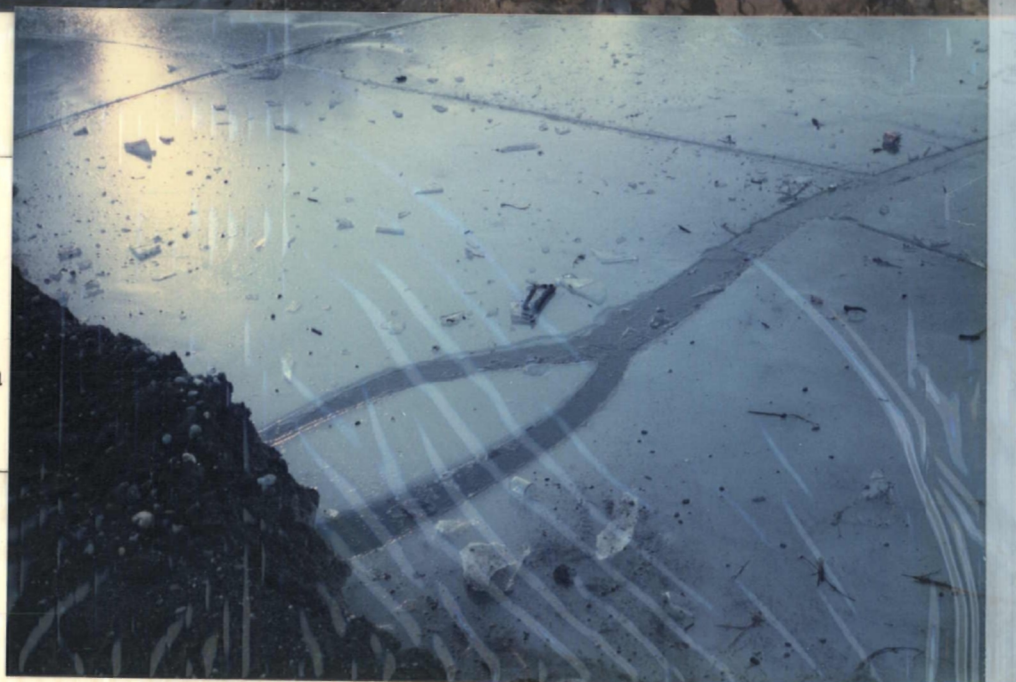
Water sample NCT091 was taken from the barrow pit across the street 40 feet to the southwest of the landfill. Permission was obtained from the property owners, the NW Concrete Company, for site access. The water in this pit is believed to be representative of upgradient groundwater. There was a layer of ice approximately one inch thick on the surface of the water. A hole was present in the ice which had been caused by cracking and shifting. A glass sample jar was placed in a holster of fishing line and then cast and dipped in the water of the barrow pit through the crack in the ice. Water was bailed in this manner until all sample bottles had been adequately filled.

Sample NCT091: N.W. Concrete Barrow pit, filled with ground-water. Across the street from the landfill and upgradient. The surface of the water was frozen and the samples were bailed from between the cracks in the ice.

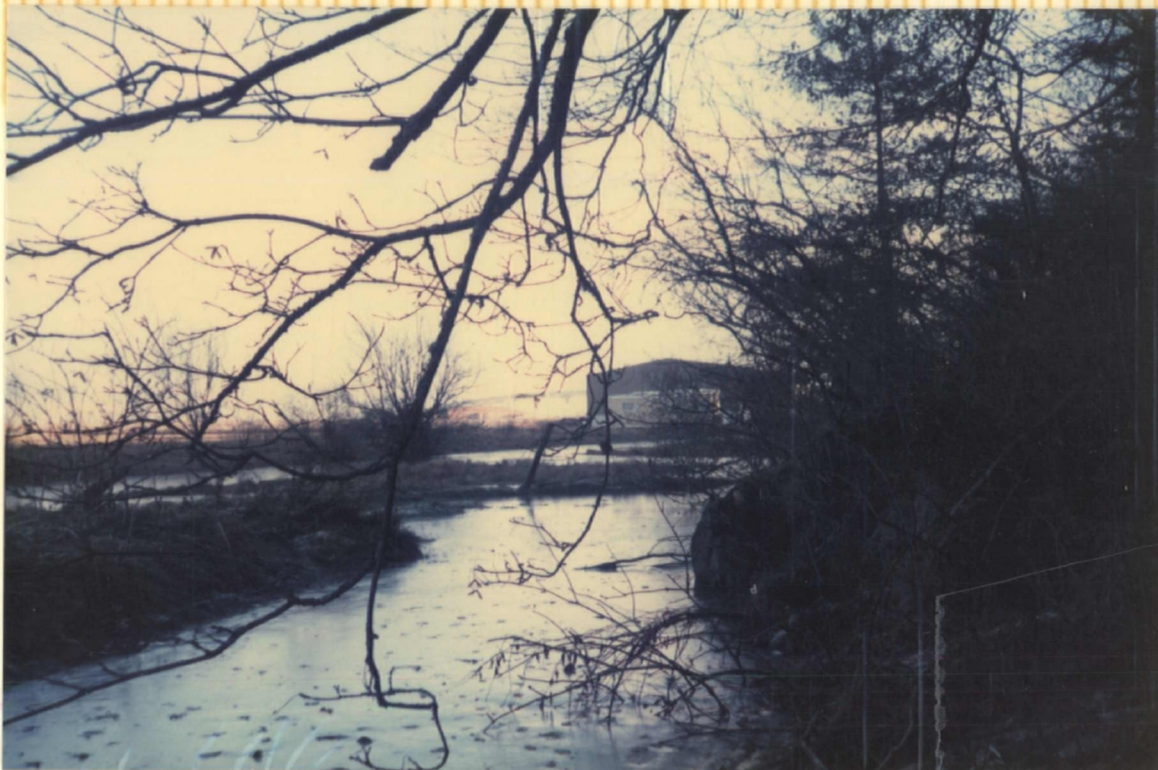
Water sample NCT092 was taken from an estuarial stream on the southeast edge of the landfill. There was also ice in this location which was broken using a shovel. Samples were collected by dipping jars in the water.

Sample NCT093 was also taken from the sediments at this location. The sediments consisted of 3 inches of black smelly organic matter underlain by grey clay. Sediments were collected using a stainless steel trier with a 1" wide tube on the end. Sediments were not frozen. The pH of this stream was sampled with pH paper and appeared close to 7.

NCT092 and NCT093: Samples were taken of water and sediment at the SW edge of the landfill from an estuarial stream which flows to Padilla Bay. The surface of the water was frozen over with 1 inch of ice.

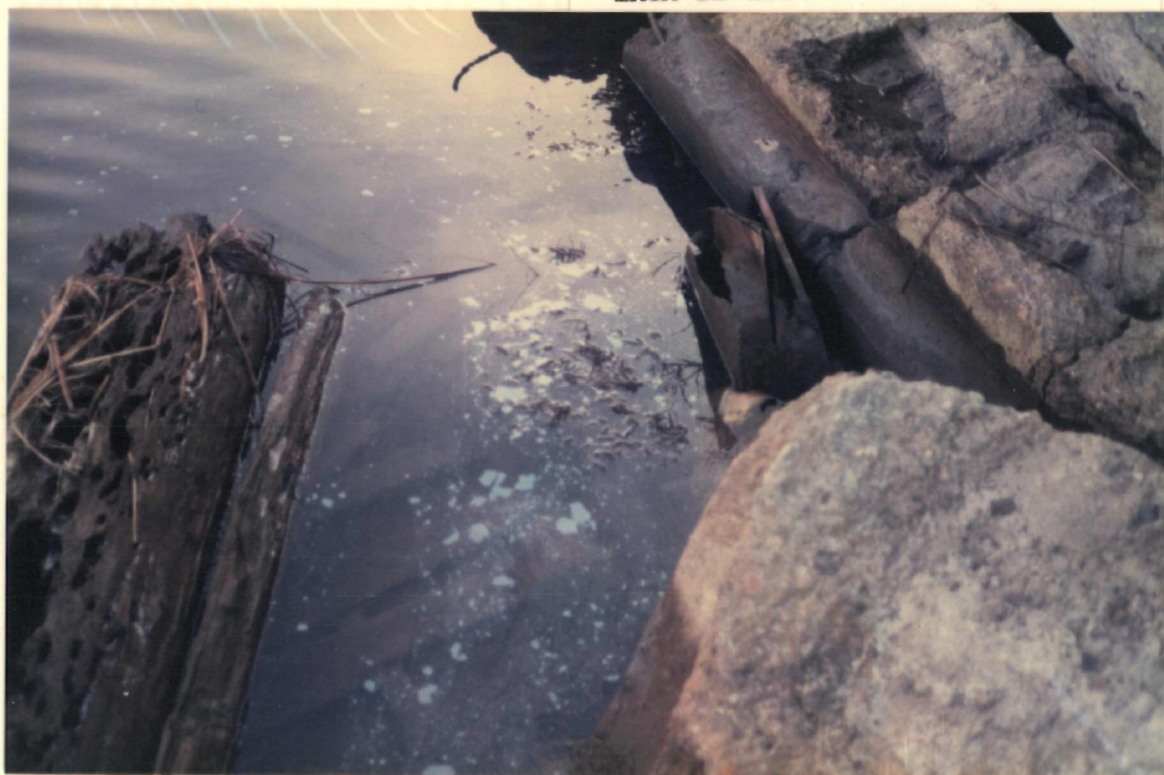
Sample NCT094: was taken of water 3 feet off shore on the East side of the landfill off of the rock dike. Sample was collected by bailing the water. There was a visible oily sheen present on the water.

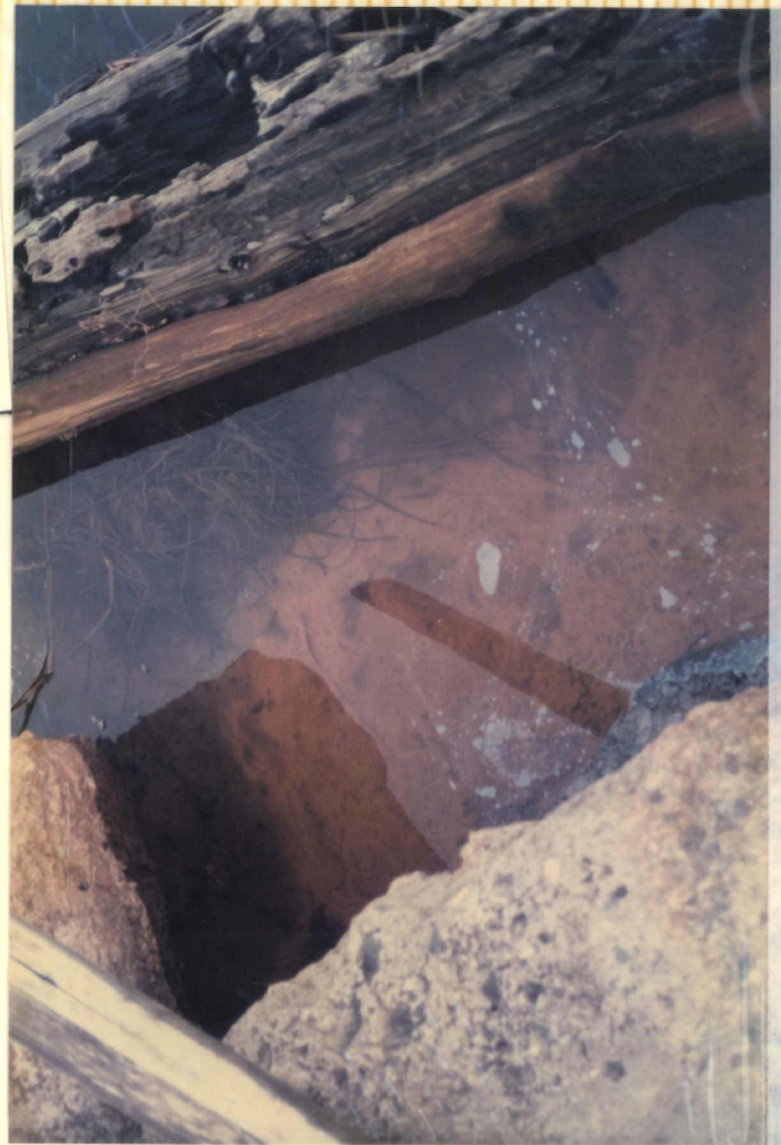
Sample NCT096 was taken from the nearshore marine sediments in this same location on the northeast side of the landfill. There was an apparent orange, rust-like top layer present along the shoreline sediments. There was also assorted rubble which could be seen under water offshore.

Sample NCT096 was taken of the marine sediments immediately off shore from the landfill on the east side in Padilla Bay. There was an apparent rust color to the top 2-3 inches of sediment. This sample was collected using a stainless steel trier.

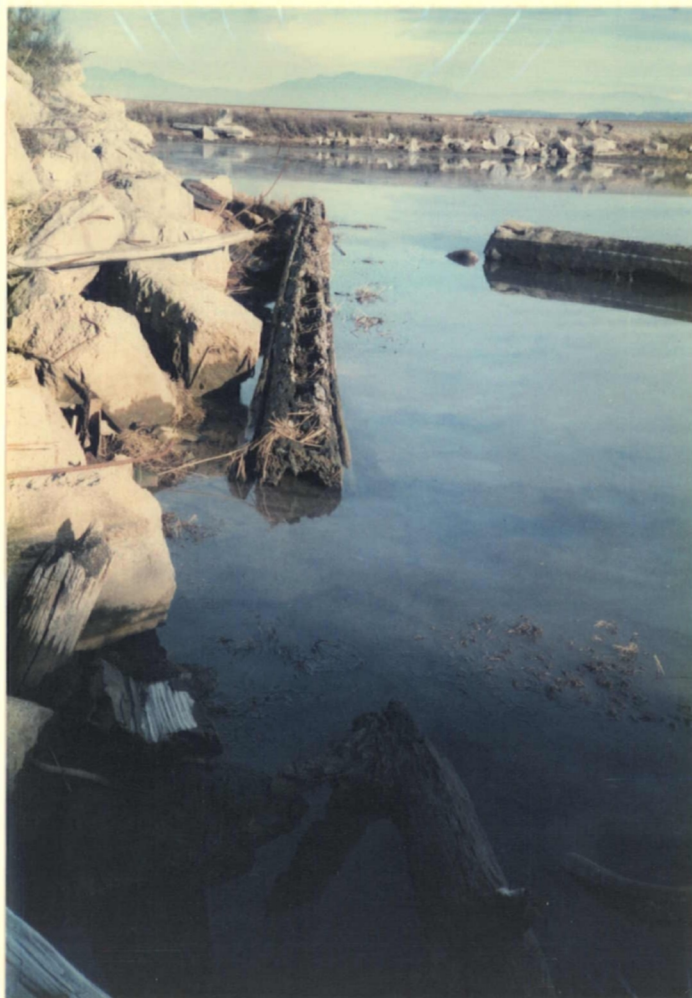
Leachate is draining into Padilla Bay. No hazardous waste was detected in this.

Sample NCT095 was taken of the leachate/seepage which was flowing from the landfill through the dike into Padilla Bay. This sample was taken from the East side of the landfill close to where sample NCT094 was collected.
